Located on Capitol Hill, the House Underground Garage (HUG) is divided into East House Underground Garage (EHUG) and West Underground Garage (WHUG). Constructed in 1968, this 45-year old facility had significant structural and safety complications due to chloride degradation. The facility consists of plaza levels, multilevel parking areas, traffic lanes, ramps between levels, offices and associated maintenance shops and egress stairways.

HYDRO-DEMOLITION – CONCRETE REMOVAL

2013 NOVA Award Nomination 18

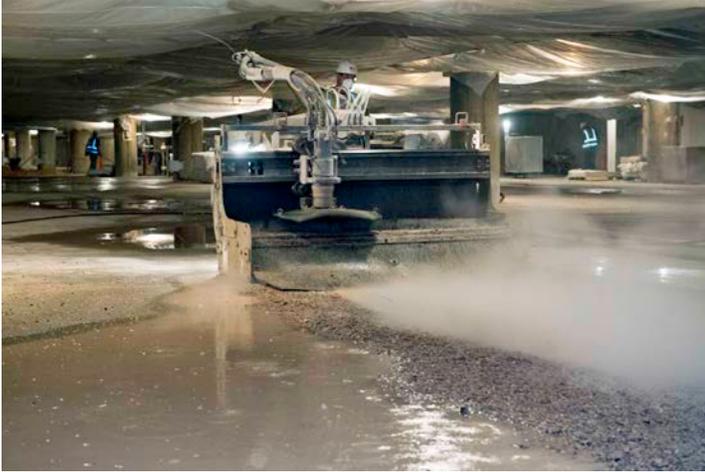
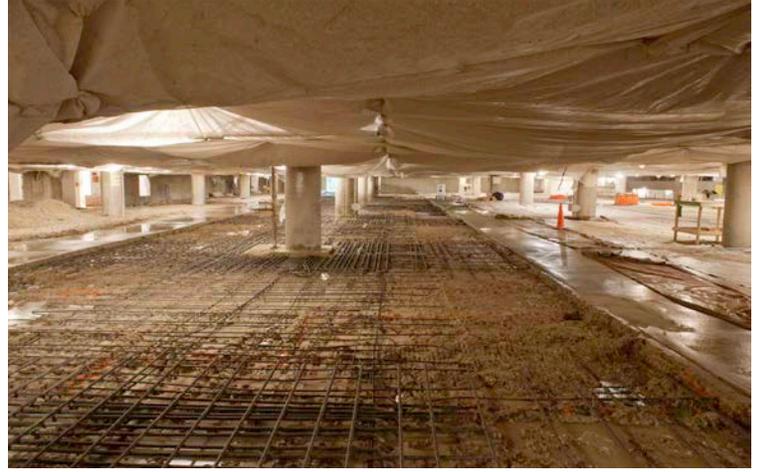
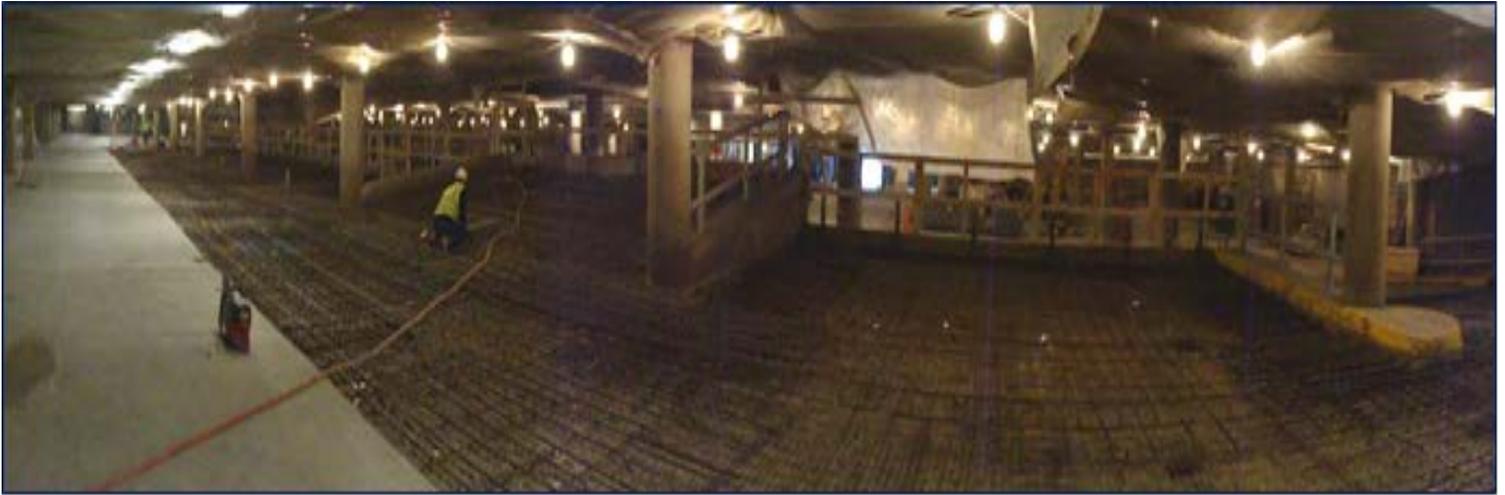
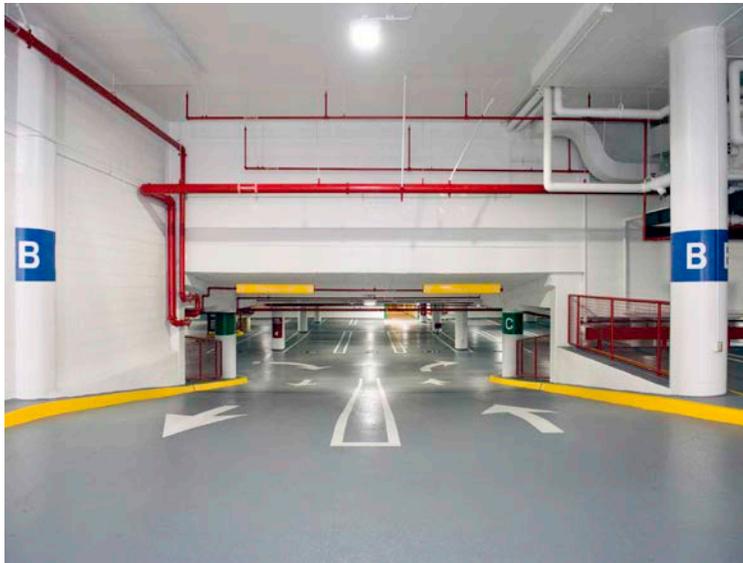
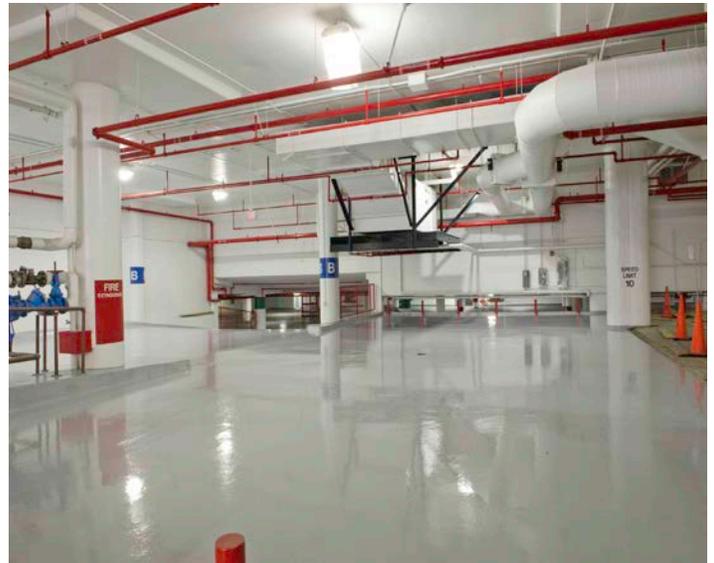
The Hydro-Demolition process uses high-pressured water to blast through concrete at specified depths. Hydro-Demolition is an ideal technique for removing concrete with its speedy production, minimum structural vibration and reduced noise levels. The process is fast paced and extremely efficient, but more importantly, precise and controllable, allowing the AOC to remove only the necessary materials, without compromising surrounding sound structures or rebar. It was imperative for both phases to be completed within their respective 12-month durations.

From a construction cost saving and environmental perspective, a major advantage of the Hydro-Demolition method is its ability to completely clean the embedded corroded reinforcing steel, providing a better bonding surface for the new concrete and eliminating a separate sand blasting process to remove the corrosion if only jack hammering was used. In addition, Hydro-Demolition eliminated costs and impacts from containment and clean-up incurred from sandblasting.
